# Report Index

1234 Sample Street, Philadelphia, PA 19121

**REPORT NO.:** 20071021.  
**DATE OF INSPECTION:** 10/21/2007.  
**TIME OF INSPECTION:** 12:59 PM.  
**CLIENT NAME:** Yvonne Hooks.  
**INSPECTOR:** Simone Cartwright - ASHI #246844.  
**AGENT/REP:** Christine Realtor, ABC Realty Company.  
**PARTIES PRESENT:** Buyer.  
**HOUSE STATUS:** Occupied with belongings. Furniture, personal belongings and household goods prevents total and complete review of some areas. A final walk through before closing is recommended.  
**INSPECTION SITE:** 1234 Sample Street, Philadelphia, PA 19121.

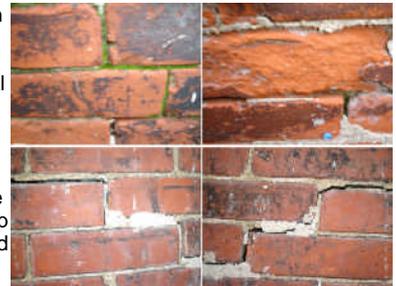
**SIDING/WALL  
CLADDING:** Brick veneer. Painted at the front. Step cracks are present in the brick mortar at: the rear above the 2nd floor middle bedroom window. Cracks in brick mortar usually indicate excessive structural stress which can be the result of several causes. Left uncorrected the damage will worsen. A structural engineer should be called in to determine the cause and recommend a course of action. (Verify) Vines and moss are on the house. This is not a good idea for vines hold moisture, promote insect damage and deteriorate brick and mortar. Ivy/vines and moss have a very strong grip and can puncture surfaces, grow behind siding, loosen it and grow under sills. Recommend removal. (Maint)(Monitor) Spalling/Deteriorated brick observed at the rear. Spalling is an indication of moisture penetration, which can be maintained by applying a water repellent coating. (Maint)(Monitor) Missing mortar present. Repointing repairs are recommended. (Maint.)

Step cracks are present in the brick mortar at: the rear above the 2nd floor middle bedroom window. Cracks in brick mortar usually indicate excessive structural stress which can be the result of several causes. A structural engineer should be called in to determine the cause and recommend a course of action.

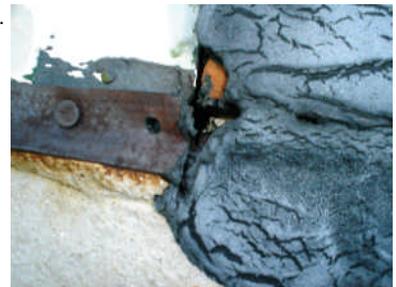
**FASCIAS/OFFIT  
TRIM:** Metal. Weathered. Openings/gaps present at front and rear. Recommend sealing to prevent damage to roof sheathing and wood framing of property. (Maint.)

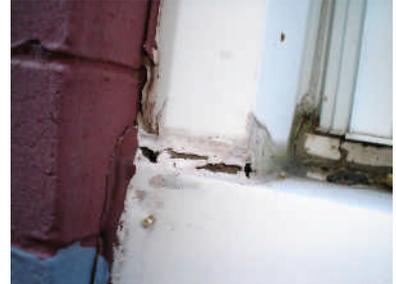
Wood. Window frames/sills are wrapped, hidden moisture damage may exist. **(Maint.)** Seal gaps around window frames to protect against rain/moisture penetration. **(Maint.)**

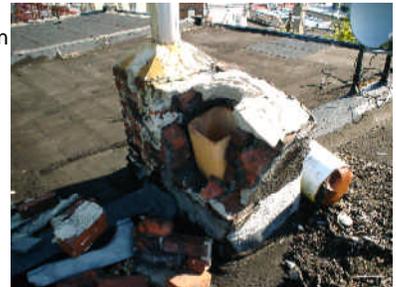
Chimney collapsed. Chimney has to be rebuilt to allow gases from appliance to escape property and prevent carbon monoxide poisoning to occupants, as well as, to protect the property from water damage. **(Verify)(Safety)**

Chimney collapsed. Recommend rebuilding to allow gases from appliance to escape property and prevent carbon monoxide poisoning to occupants, as well as, to protect the property from water damage.

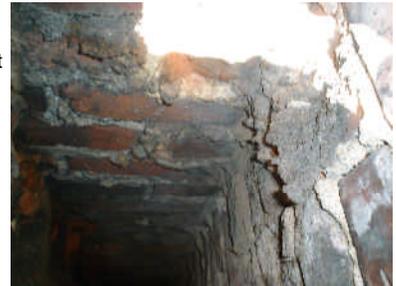
There is no spark arrester/rain cap. Installation is recommended to enhance fire safety, prevent water, rodent and debris penetration. **(Maint.)** Creosote buildup is present at the top of the chimney. This is an indication the chimney has not been regularly cleaned and could be a fire safety concern. Cleaning of the flue by a chimney sweep is recommended prior to use. **(Safety)(Verify)** The chimney stack appears to have an unlined flue. While this may have been acceptable at the time of construction, flue liners are a fire safety feature which should be installed. **(Upgrade)(Verify)**

Creosote buildup is present at the top of the chimney. This is an indication the chimney has not been regularly cleaned and could be a fire safety concern. Cleaning of the flue by a chimney sweep is recommended prior to use. The chimney stack appears to have an unlined flue. While this may have been acceptable at the time of construction, flue liners are a fire safety feature which should be installed.

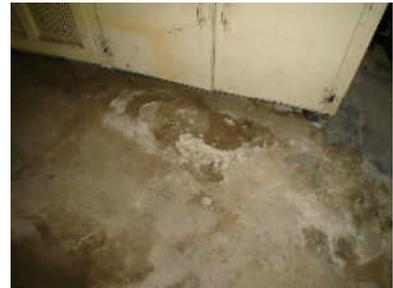
**FOUNDATION TYPE:** Basement.  
**SLAB:** Concrete.  
**FLOOR CONDITION:** Efflorescence is present. This is the whitish mineral deposit left behind from persistent exterior water/ moisture penetration. (Verify)

Efflorescence is present. This is the whitish mineral deposit left behind from persistent exterior water/ moisture penetration.

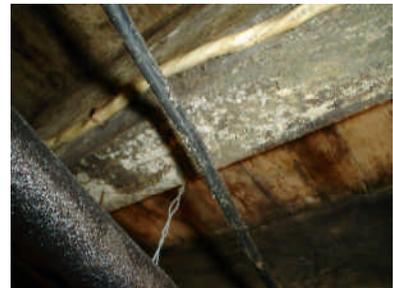
**FLOOR JOISTS:** Serviceable where visible EXCEPT: Fungus/mold like substance present on joists at the rear right side. Recommend further evaluation by qualified mold specialist. (Verify)

Fungus/mold like substance present on joists at the rear right side. Recommend further evaluation by qualified mold specialist.

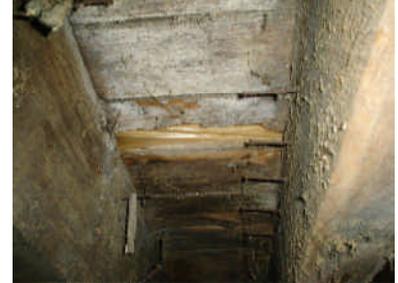
Deteriorated subflooring due to moisture is present at rear right side. Repairs have been made. (Maint)(Monitor)

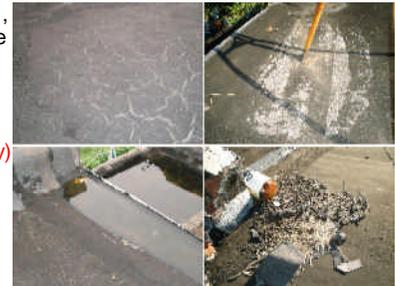
<b>LOCATION:</b>	Main.
<b>ROOF TYPE:</b>	Flat.
<b>INSPECTION METHOD:</b>	Walked.
<b>ROOF COVERING:</b>	Rubber/membrane.
<b>NUMBER OF LAYERS:</b>	It appears this roof has more than three layers.
<b>APPROXIMATE AGE:</b>	Unknown.
<b>ROOF CONDITION</b>	Roofing materials show signs of age and wear with cracking, deterioration, ponding and soft areas which are an indicative of past water penetration to the roof sheathing. Excessive debris is observed on the roof. This will decrease any remaining useful life of the roofing materials and increase the risk for roof leaks. Removal of debris is recommended. <b>(Maint)</b> Repair/replacement of roof is recommended. <b>(Verify)</b>

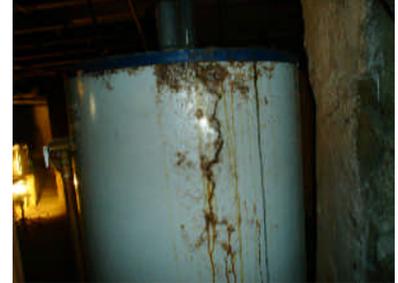
Tank is cracked and rusted. Replacement is needed.  
(Verify)

Tank is cracked and rusted. Replacement is needed.

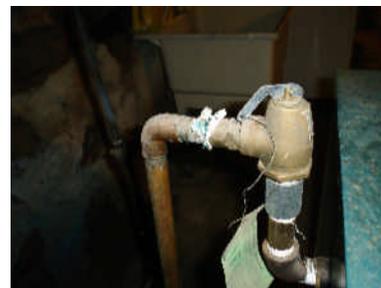
**T/P RELIEF VALVE:** Rust/Corrosion observed on Temperature Pressure Relief Valve. Recommend repair/replacement. **(Safety)**

Rust/Corrosion observed on Temperature Pressure Relief Valve. Recommend repair/replacement.

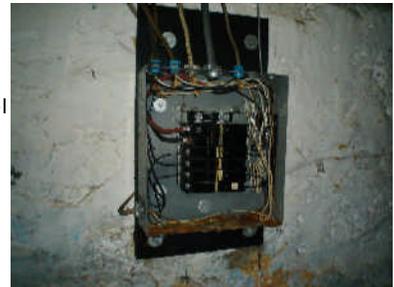
**Inspector Notes:** Missing panel cover. This is a **LIFE SAFETY HAZARD** due to exposed hot wiring. Recommend panel cover be install immediately., Rusting observed inside main panel. This is usually an indication of water or condensation. **(Maint)(Safety)** Identify circuits and create labels once panel is replaced. **(Upgrade)**

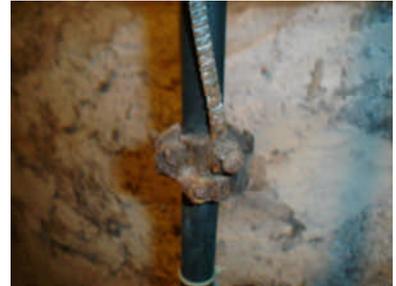
Grounding provided by an exterior ground rod and the homes interior plumbing. Rust observed on the jumper ground clamp. This condition will reduce the conductivity. Recommend replacement of clamp. (Maint)(Safety)

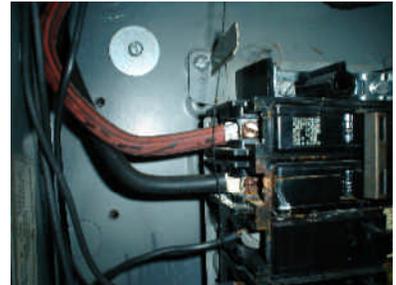
Circuit breakers. Breaker terminal is corroded. Corroded terminals can prevent proper conductivity. Repair/cleaning of the terminals by a licensed electrician is recommended. (Verify)

Corrosion present on breaker terminal. This condition can prevent proper conductivity. Repair/cleaning of the terminals by a licensed electrician is recommended.

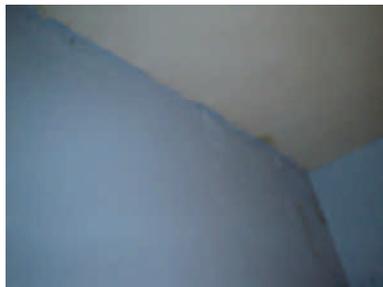
- FLOORS:** Serviceable. Wood. Vinyl.
- WALLS:** Serviceable. Plaster.
- CEILINGS:** Plaster. Moisture stains observed in 3rd floor front bedroom around chimney area. Stains tested dry with moisture meter at time of inspection, however there has been NO rain for several days. Active stains only manifest themselves during specific conditions (i.e. during wind and rain). Recommend client confirm from seller if the stains are related to a previously repaired problem. (see chimney and roofing comments) *(Verify)*
- DOORS:** Serviceable.
- WINDOWS:** Serviceable.
- STAIRS/RAILING:** Serviceable.

Moisture stains observed on 3rd floor ceiling around chimney area. Stains tested dry with moisture meter, however there has been NO rain for several days. Active stains only manifest themselves during raining conditions. Recommend client confirm with seller or licensed roofer if stains are related to a previously repaired problem. (see chimney & roof comments)
