# Report Index

1234 Sample Street, Philadelphia, PA 19121

**REPORT NO.:** 20071021.  
**DATE OF INSPECTION:** 10/21/2007.  
**TIME OF INSPECTION:** 12:59 PM.  
**CLIENT NAME:** Yvonne Hooks.  
**INSPECTOR:** Simone Cartwright - ASHI #246844.  
**AGENT/REP:** Christine Realtor, ABC Realty Company.  
**PARTIES PRESENT:** Buyer.  
**HOUSE STATUS:** Occupied with belongings. Furniture, personal belongings and household goods prevents total and complete review of some areas. A final walk through before closing is recommended.  
**INSPECTION SITE:** 1234 Sample Street, Philadelphia, PA 19121.

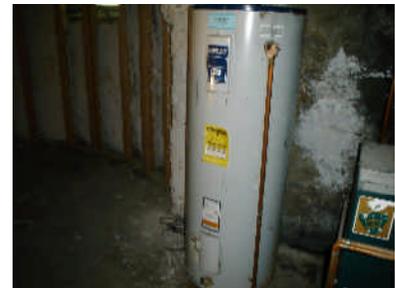
**LOCATION:** Basement.

**CAPACITY:** 80 Gallons.

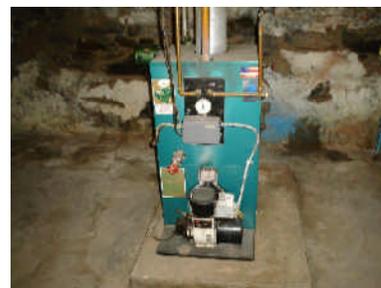
**LOCATION:** Basement.

**THERMOSTAT:** Serviceable. Located in: dining room.  
**BRAND:** Columbia Emerald, Model #EM-125, Serial #31012.

**APPROXIMATE AGE:** Unable to determine.  
**FUEL:** Oil.  
**TYPE:** Hot water heating. Forced hot water system (Hydronic/Circulating) type.
